# FACILITY COMPLIANCE AUDIT REPORT

### Solid Waste Section

**Date of Audit:** March 24, 2011**Date of Last Audit:** February 18, 2010**FACILITY NAME AND ADDRESS:**

Halifax County C&DLF, Closed MSWLF and Industrial Coal Ash Landfill  
921 Liles Road  
Halifax, NC 27839

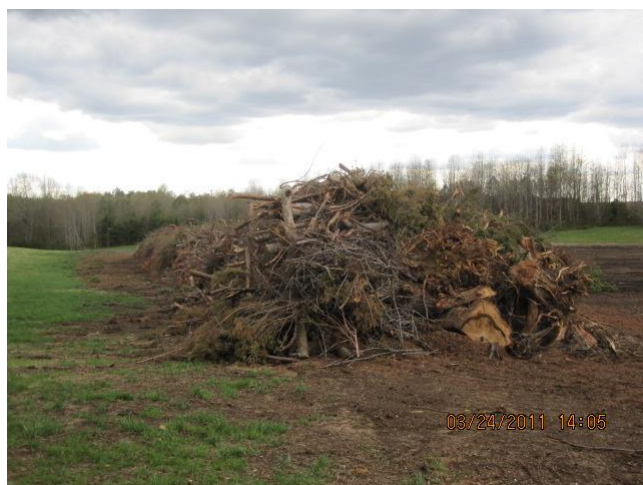
11. There was some windblown observed. Windblown is to be picked up daily.
12. The yard waste area looks very good. There was very little unacceptable debris observed. The material is being windrowed until it is ground and removed for boiler fuel.

Yard Waste windrowed.

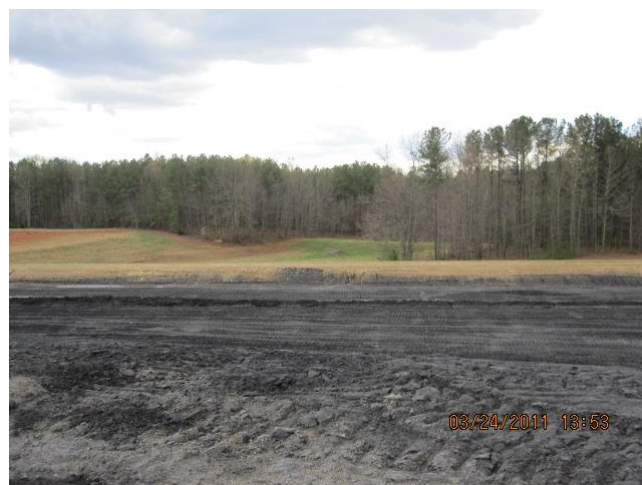
3. The liner at the Industrial coal ash landfill has been repaired. Approval was given by the Solid Waste Section after testing of the integrity of the existing liner was shown.

Coal ash with liner at berm

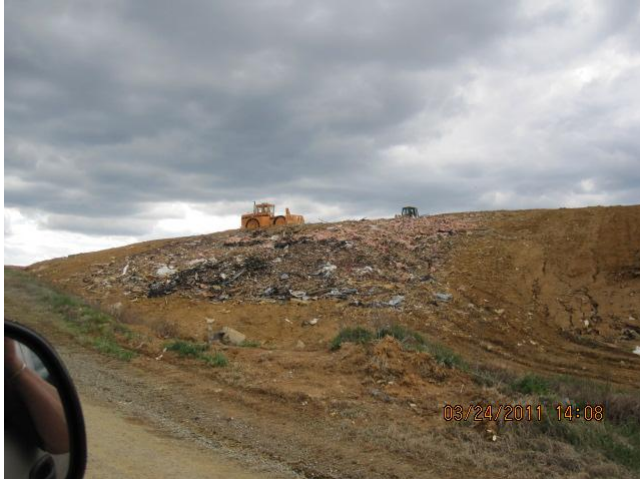
8. The C&D working face appears to be small and well compacted. More cover is needed in some areas where some C&D is partially visible.
9. The Edge of Waste markers were clearly visible.

Working face at C&D LF

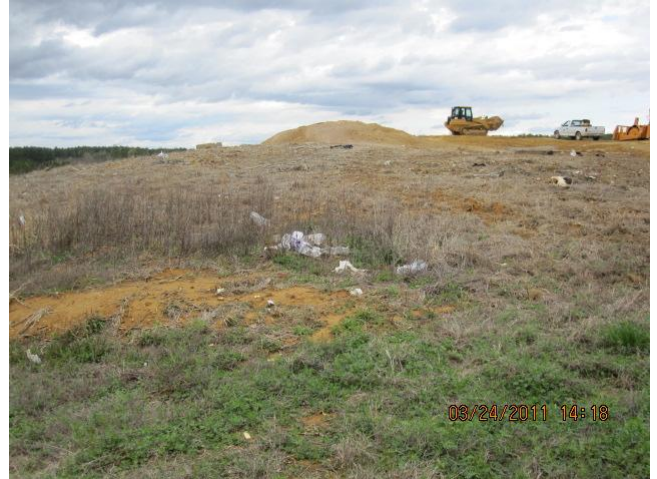
Some windblown observed
